Infrared Seat Sensor
installation-
intructions

vehicle
Mercedes W 211

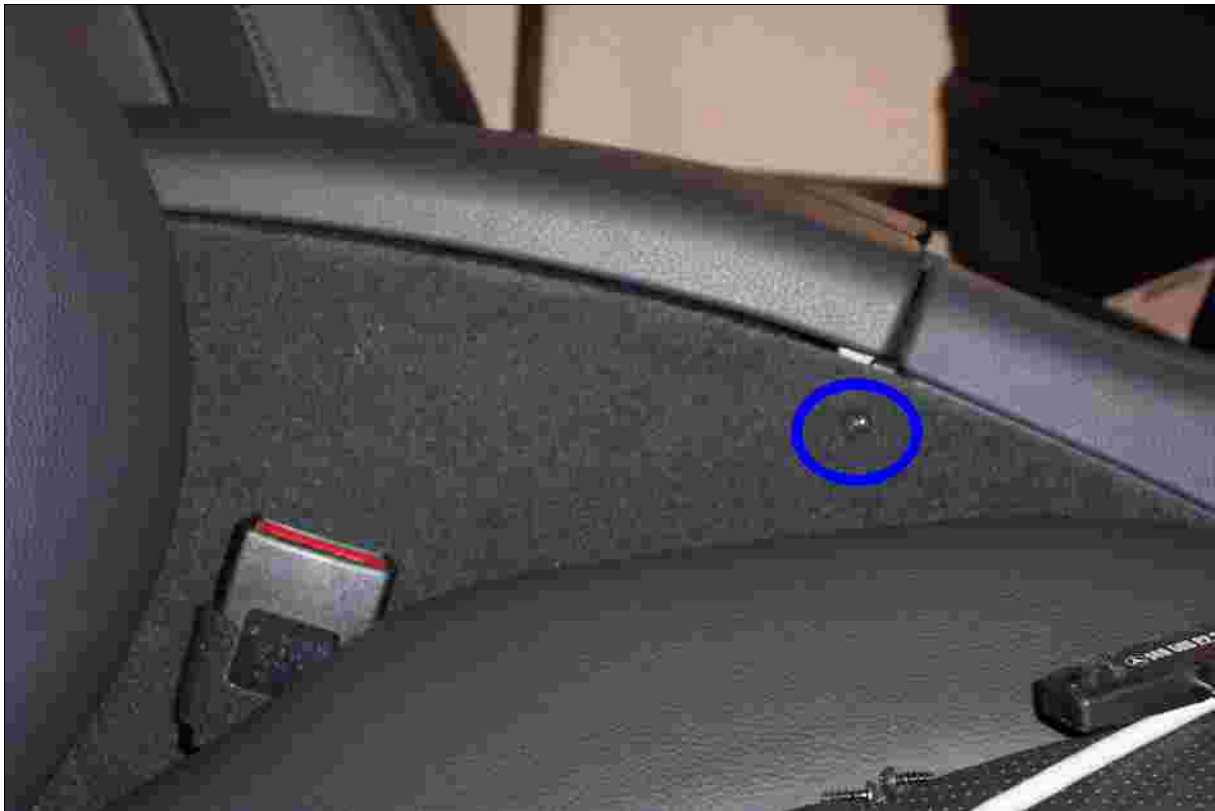
1 mounting transmitter in the central console

Please consider to drill the mounting holes exactly at the shown places.

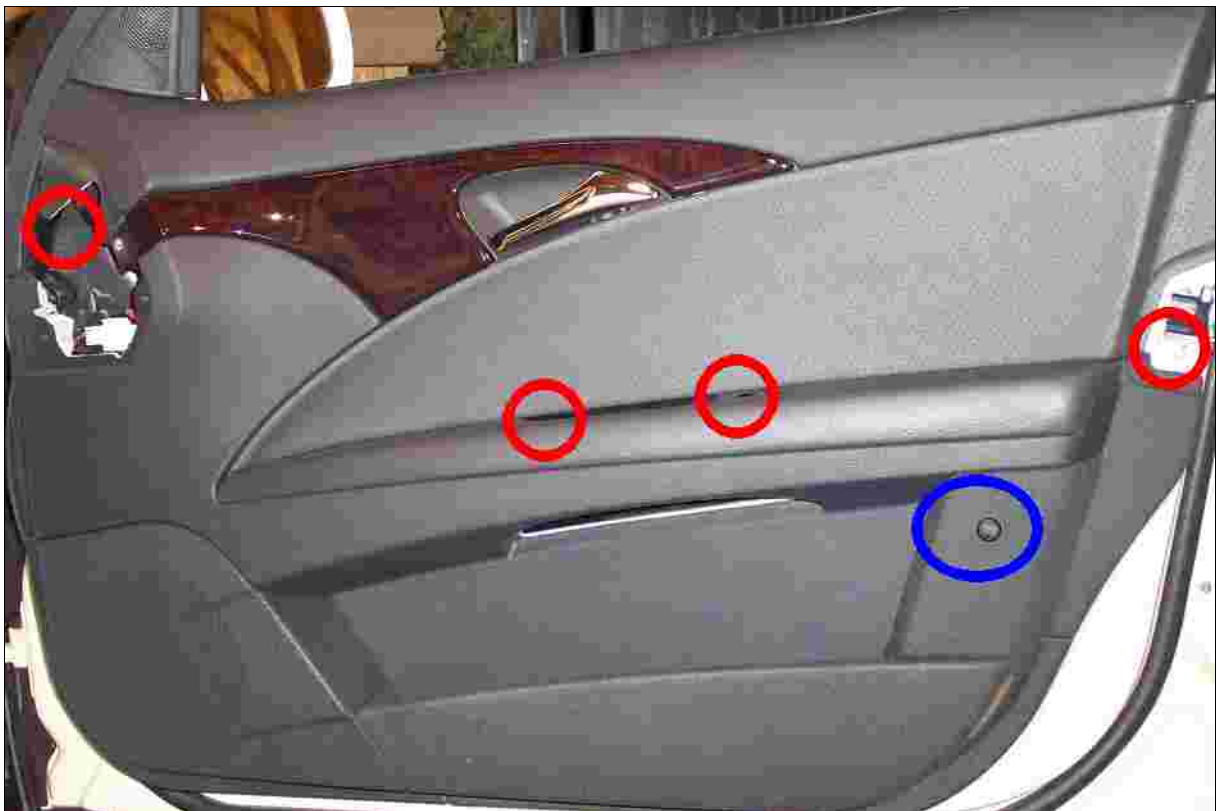
2 Receiver mounting front door panel

(screws are marked red , reciever marked blue)

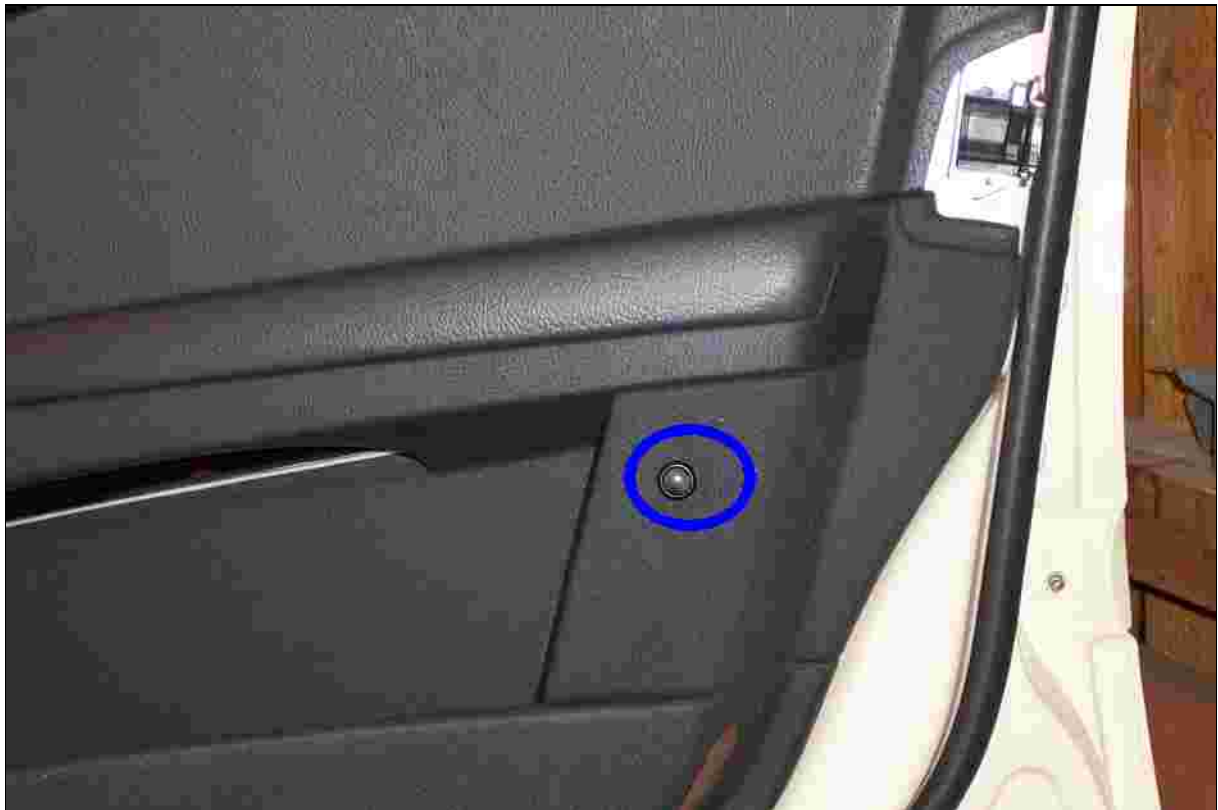
detail of the receiver in the front right door panel

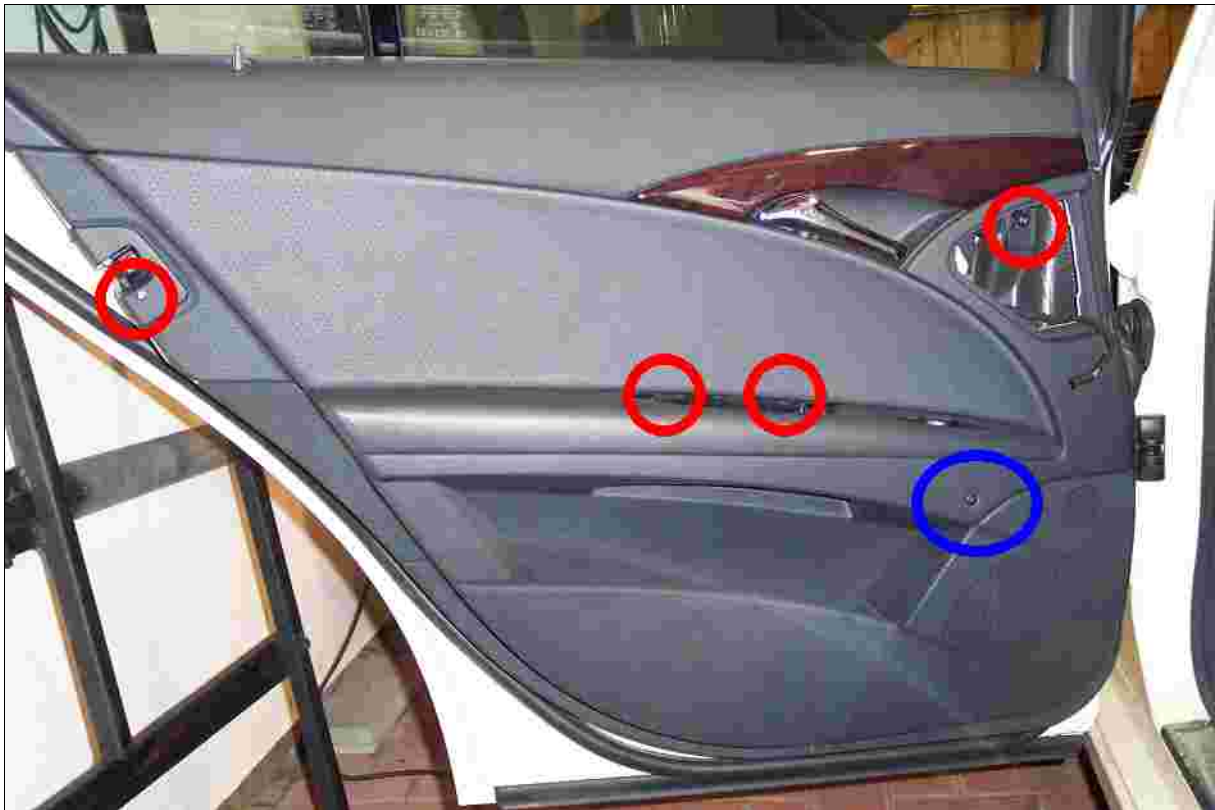
3 Transmitter in the left back door panel

! always be aware that the light of the transmitter hits exactly the receiver on the opposite doors panel. When not fulfilling this basic need, the system will become sensitive against disturbances like light flashes, intermitting light, direct sunlight.

Simple test: First take a look if the receiver and transmitter are placed in one line in the back as well as in the front.

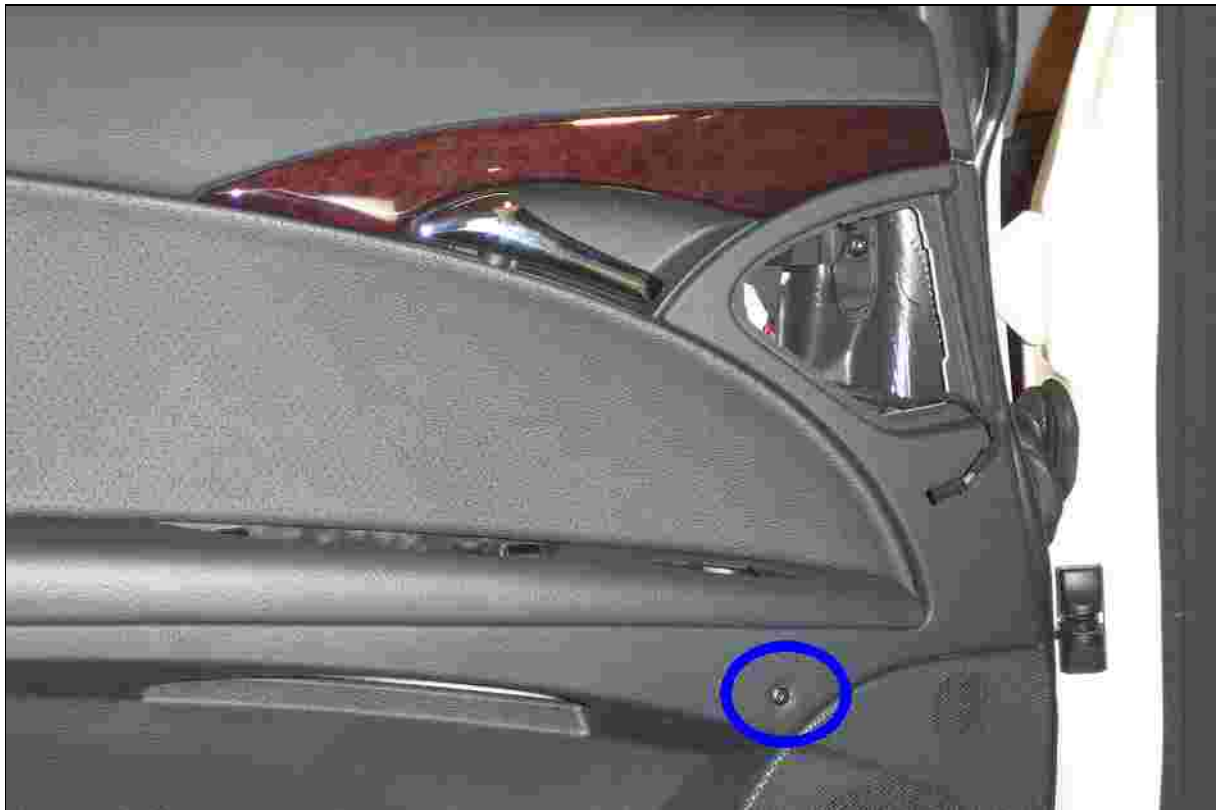
detail of the transmitter in the left back door panel

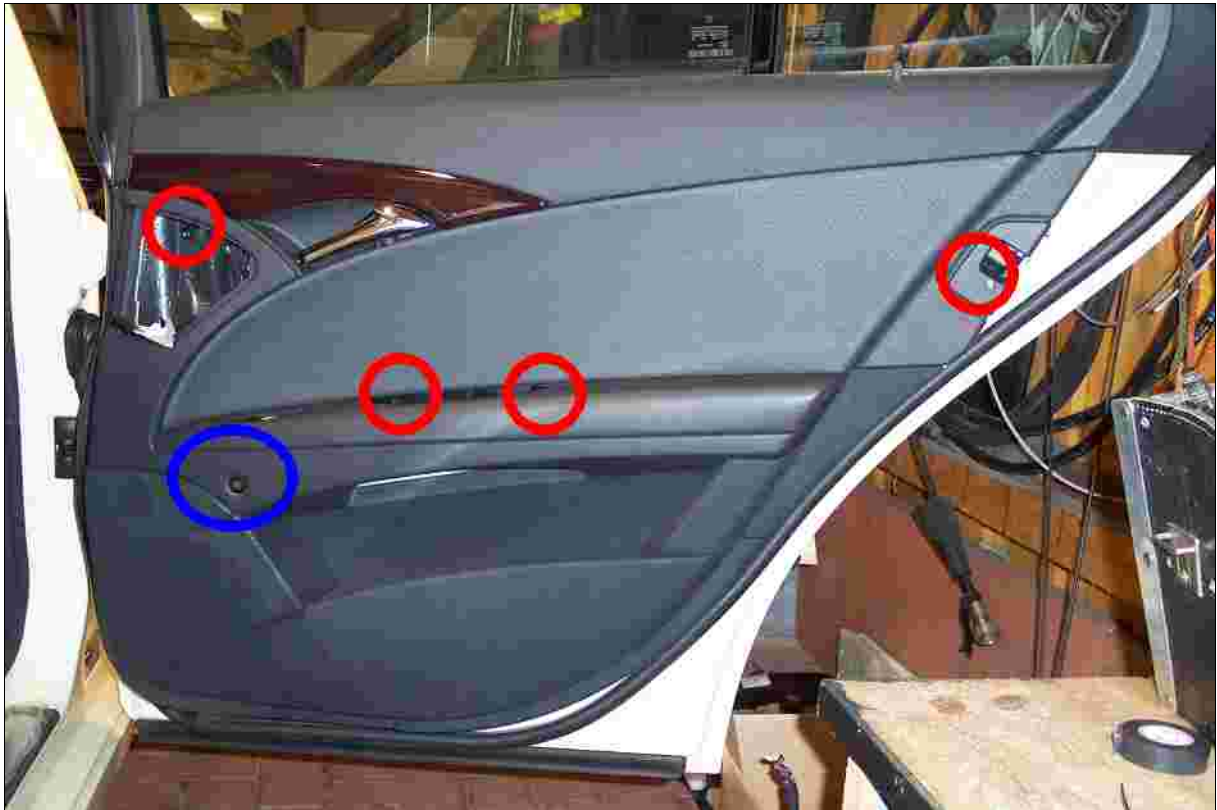
4 receiver mounting in the right back door panel
(screws are marked red, receiver is marked blue)
